Location and Type of NESC Violation

Re: Oncor Safety Violations

TWC's safety expert was in the Dallas area on May 13-15, 2008, and he took photographs of a number of typical safety violations he found on Oncor poles. Copies of marked-up photos depicting the violations are enclosed here. The locations of the photos are as follows:

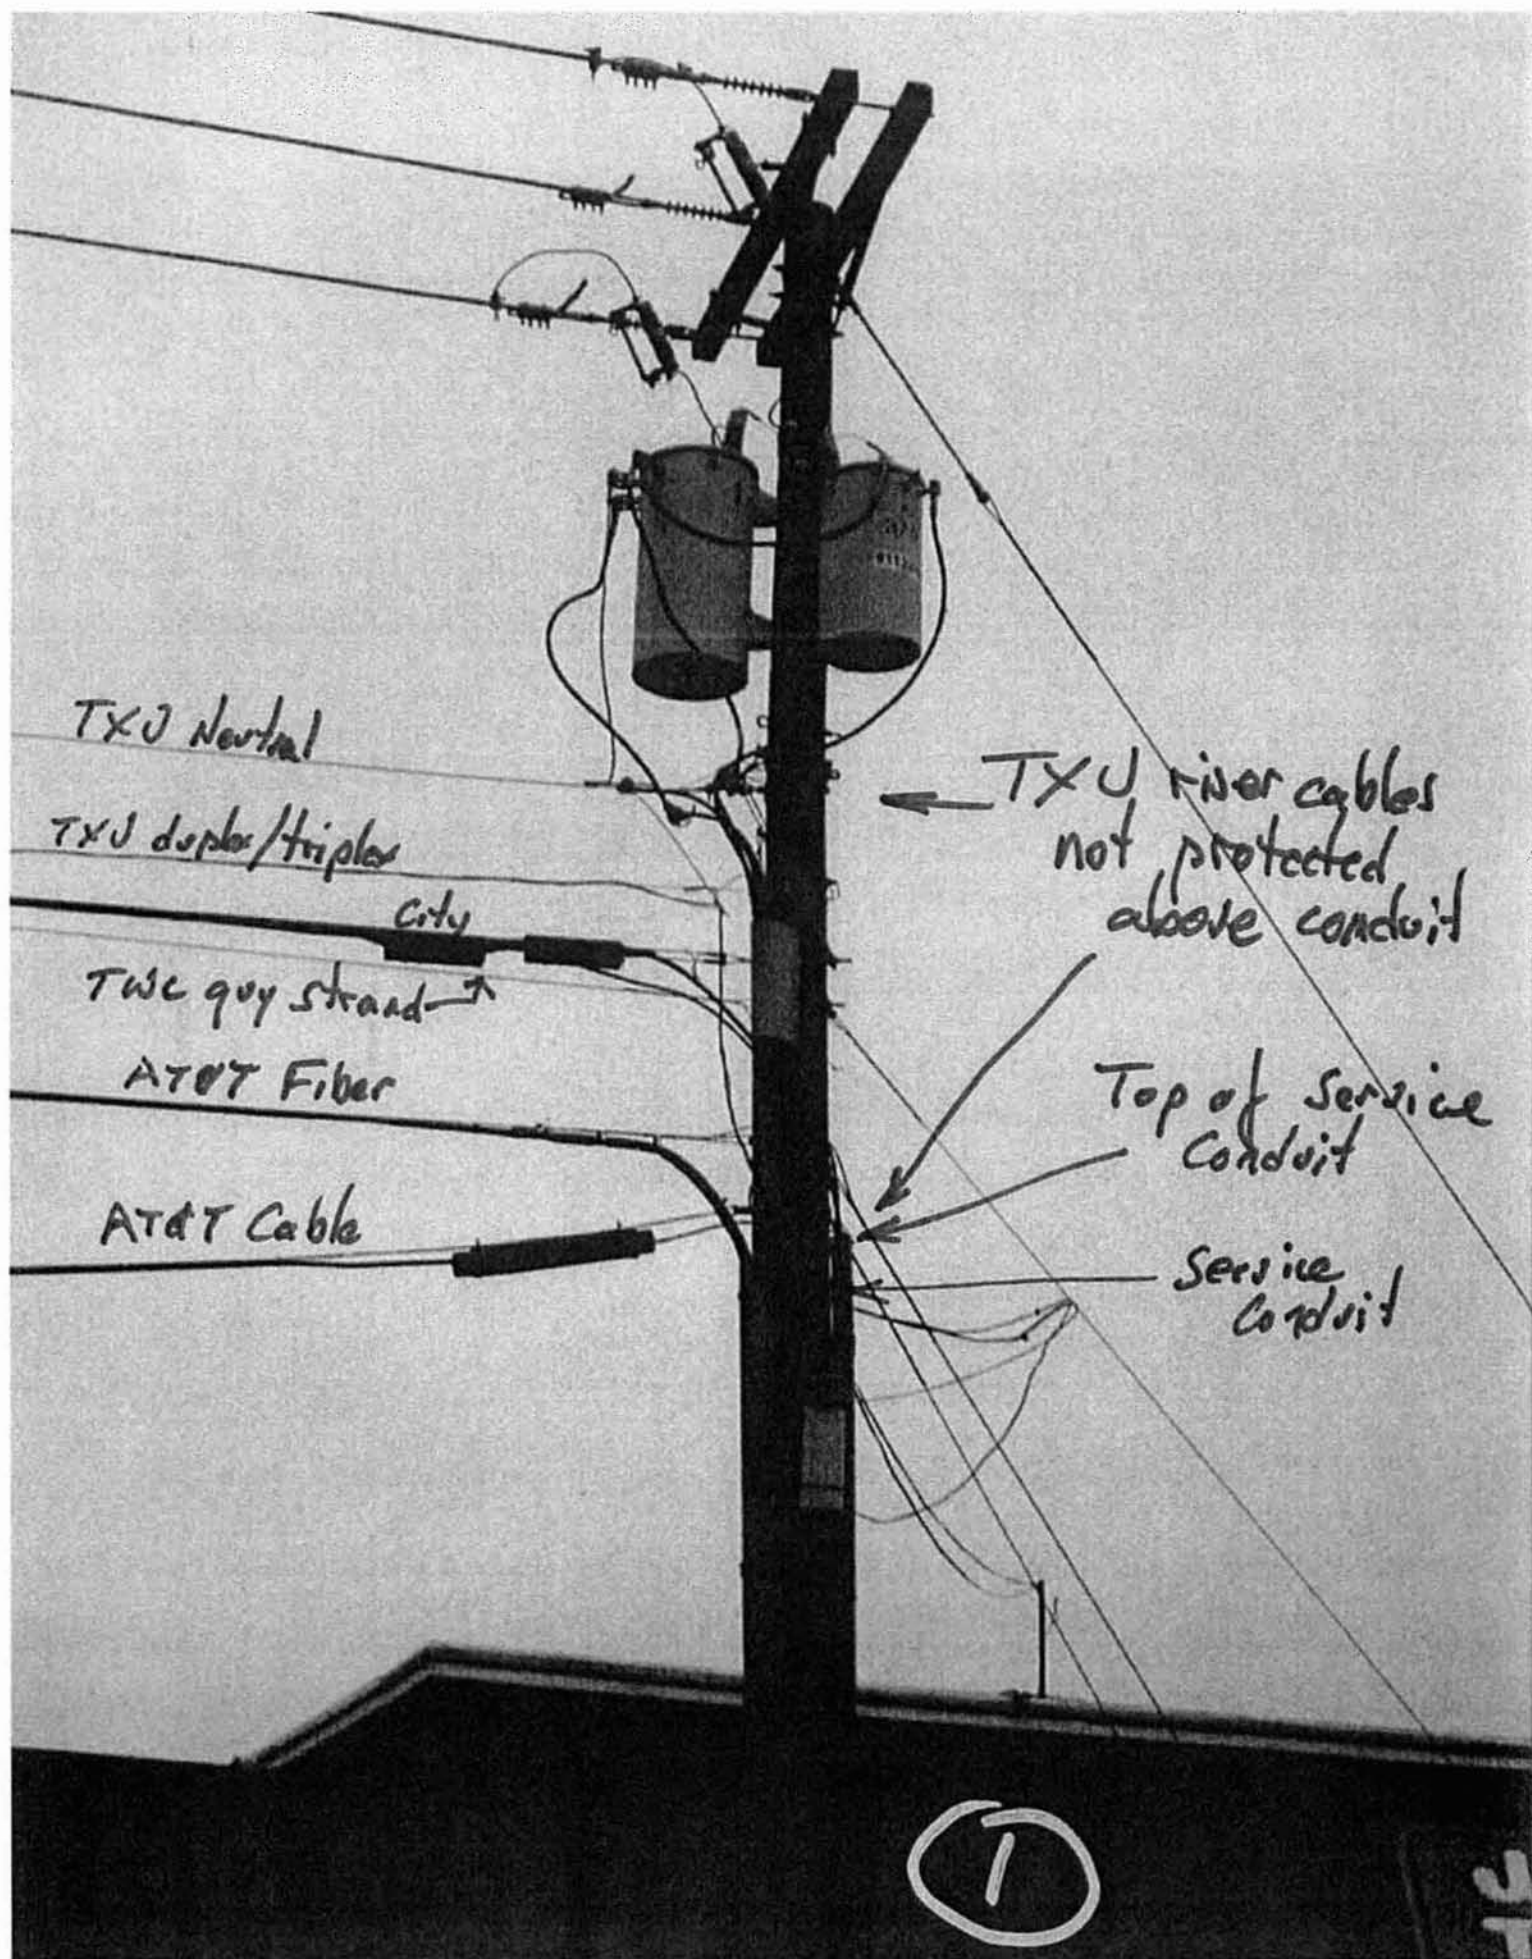
Photo 1 – First pole south of Division:

TXU triplex pole attachment:

TXU-TWC, TXU-probable.

TXU-City, cause unknown.

TXU unprotected riser:

TXU-TWC, TXU-caused.

TXU-AT&T, TXU-caused.

TXU-City, TXU-caused.

TXU riser cables
not protected
above conduit

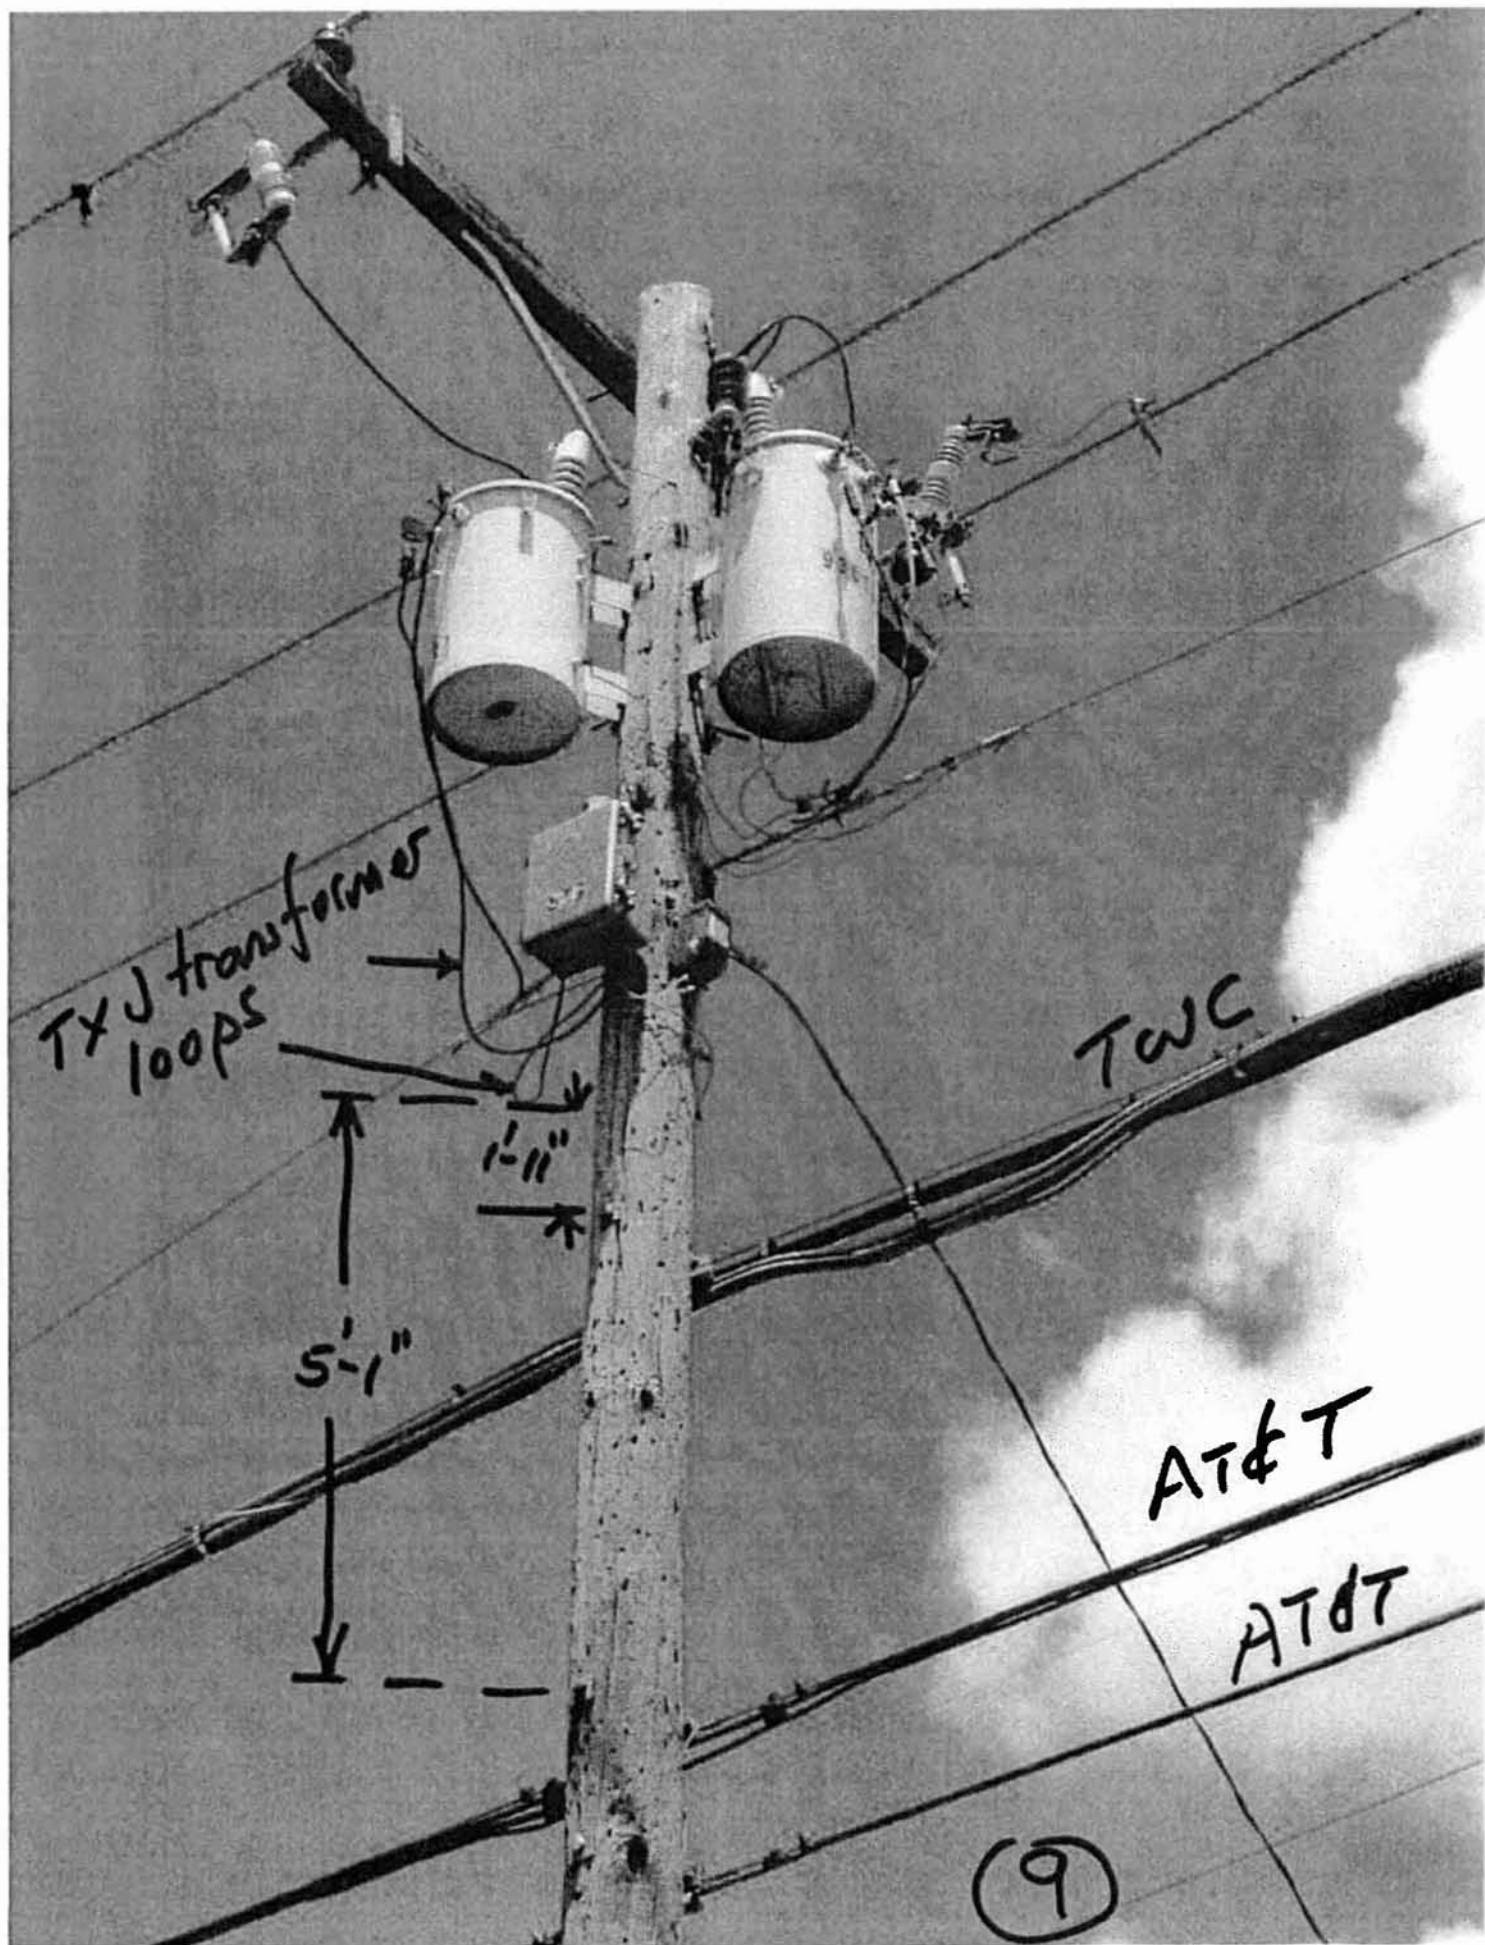
(9)

Photo 9 – Third pole north of Finley. This is excessive sag in TXU transformer leads feeding control box, TXU-TWC, TXU-probable.

TX J transformer
100PS

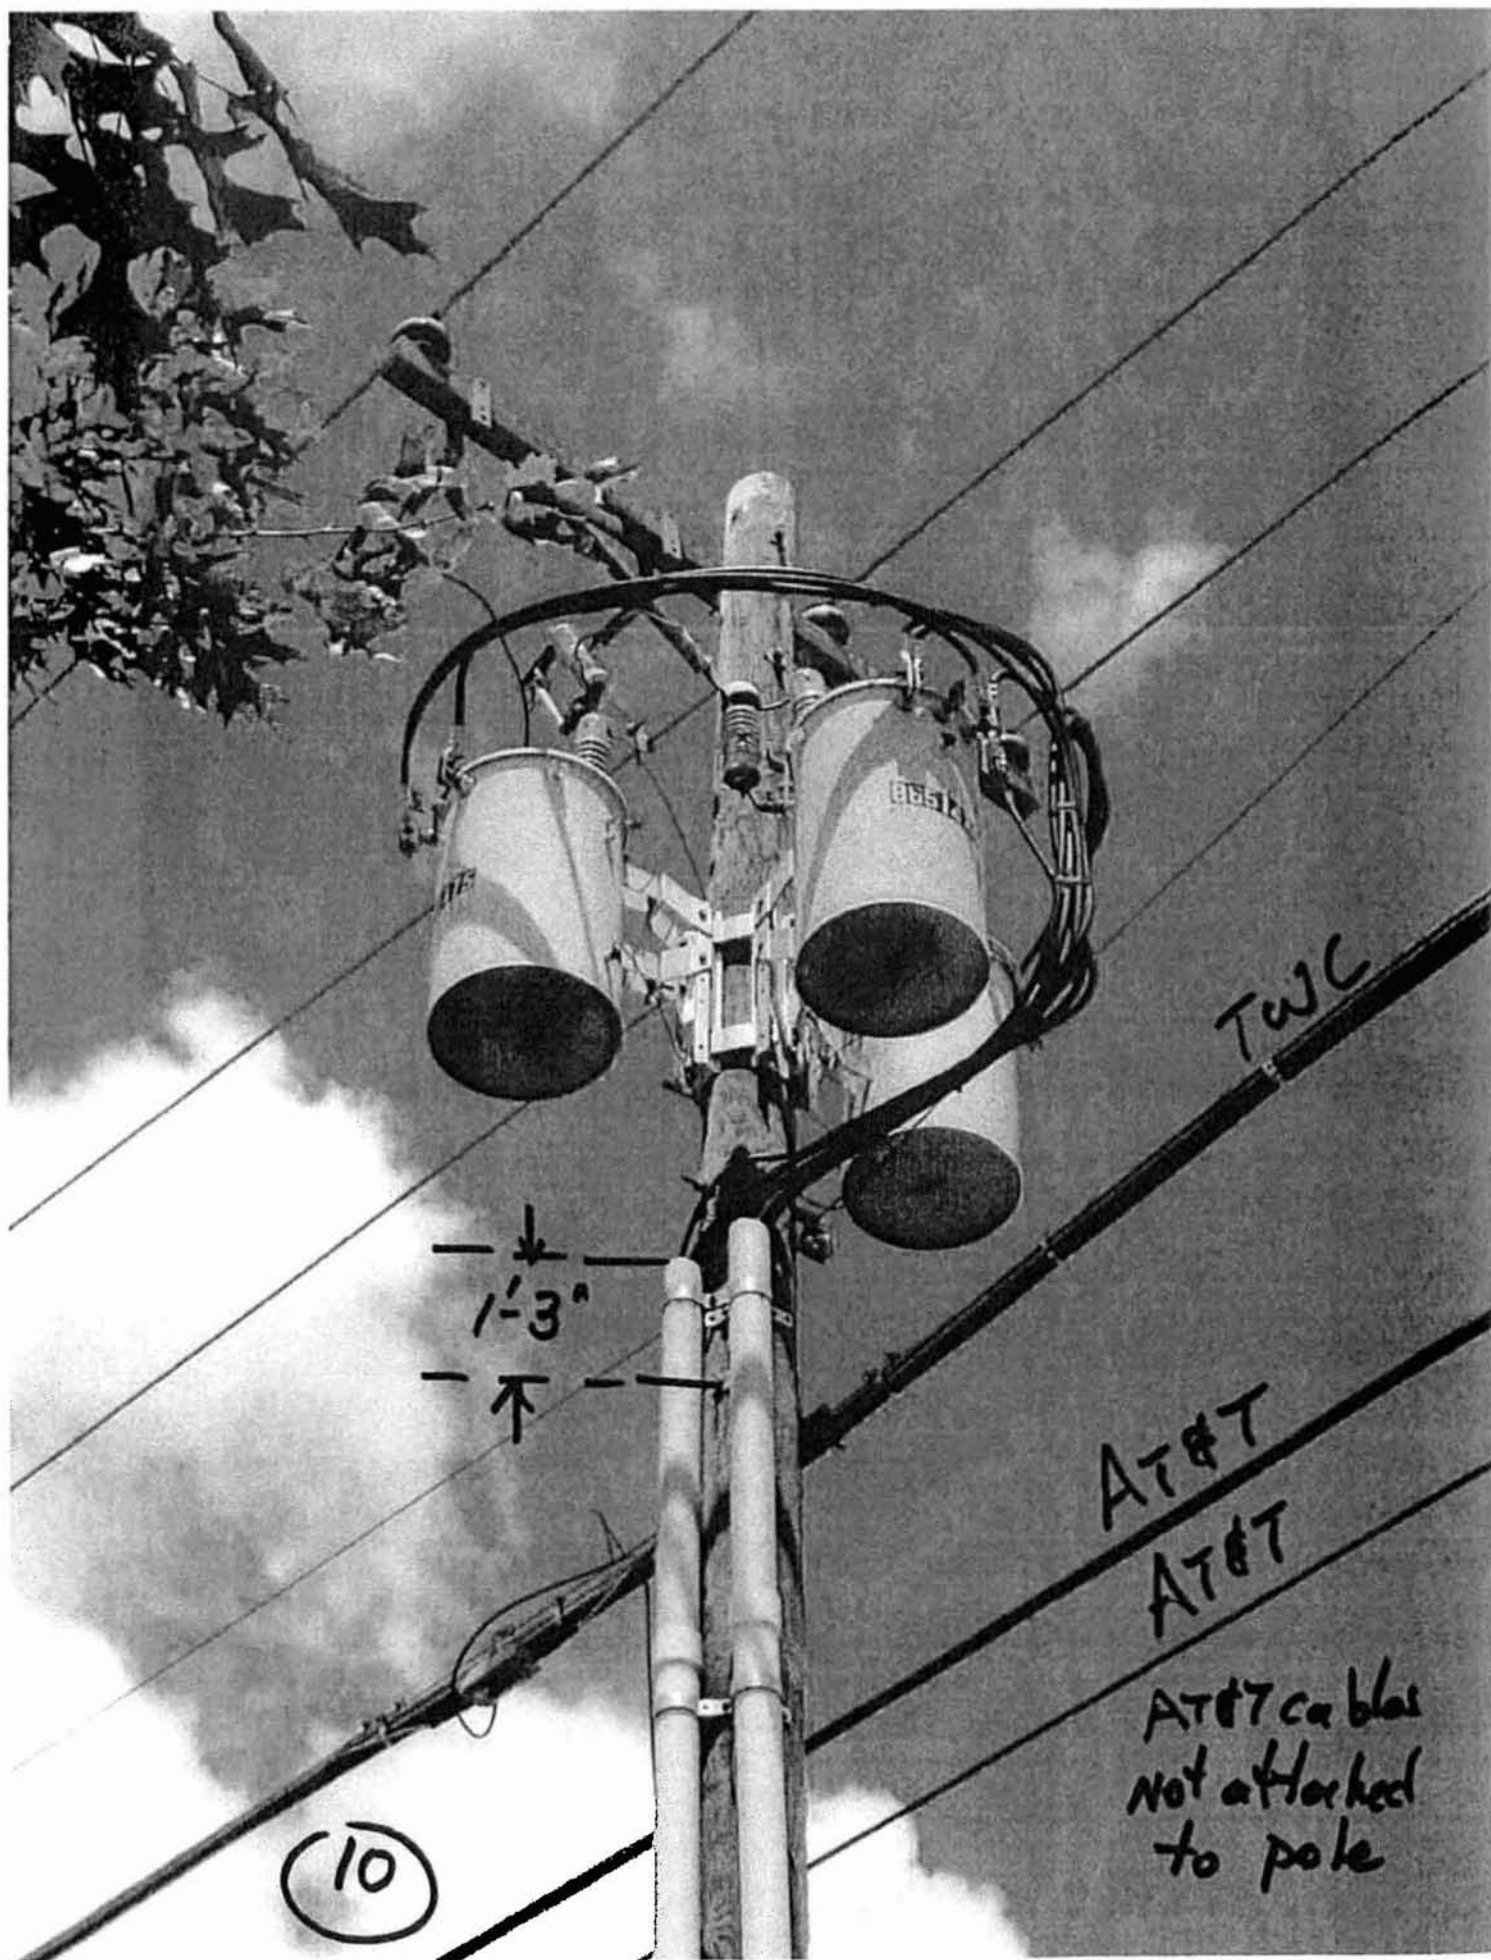
(10)

Photo 10 – Fourth pole north of Finley. These are TXU unprotected risers, new conduits, TXU-TWC, TXU-caused.

AT&T cables
not attached
to pole
